Black Hawk Helicopter Vibration Analysis Due to Main Rotor Damage, Directional Constituents of the Resultant Vibrations

ARL-TR-2442

March 2001

Survivability/Lethality Analysis Directorate, ARL

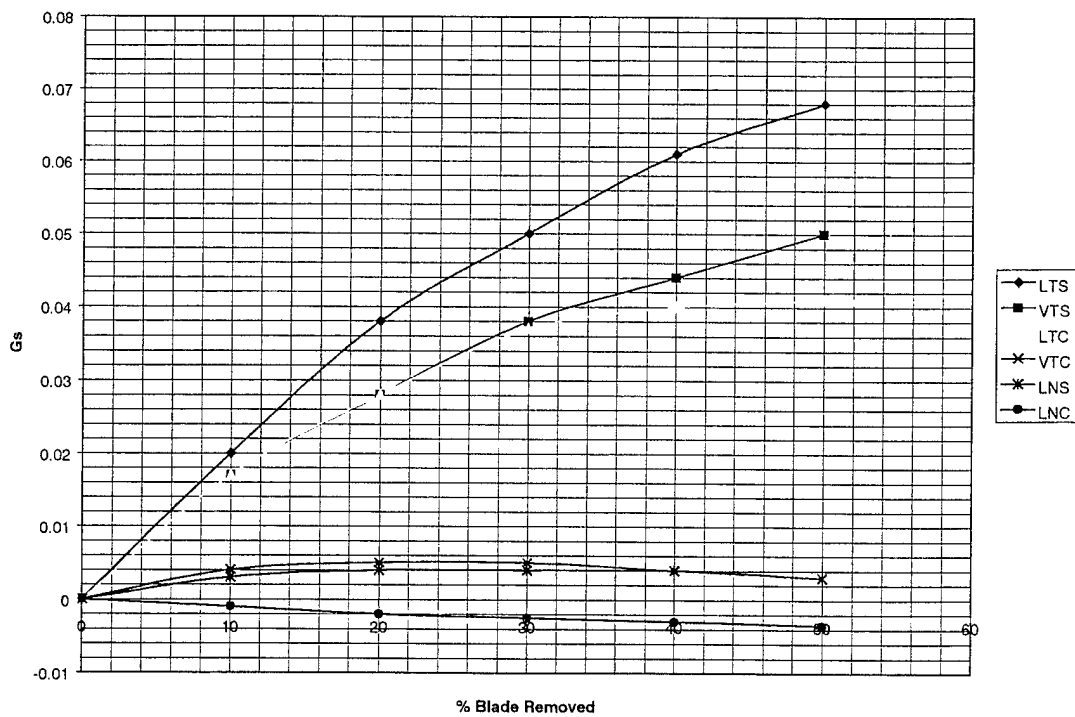
Next are the 3/Rev vibrations illustrated in Figure 4. In a normal undamaged rotor, none of these 3/Rev vibrations would occur for a 4-bladed rotor.

Figure 4. 3/Rev cockpit constituent vibrations G's vs. percent of blade removed.

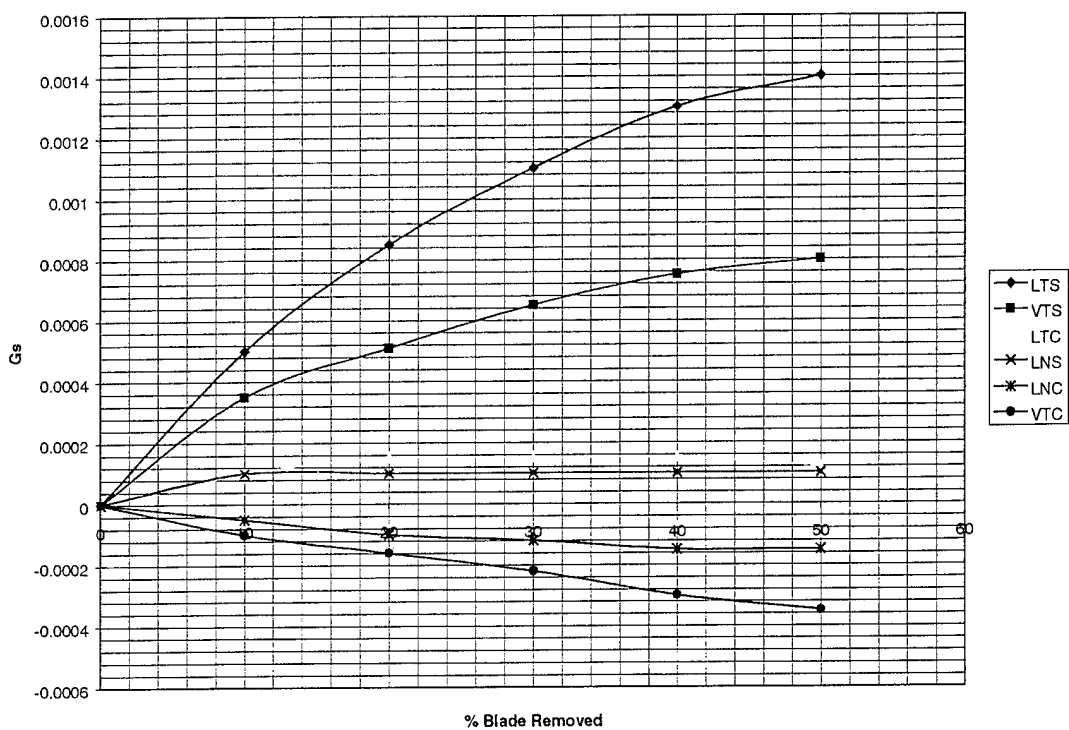
Finally, the 5/Rev vibrations are illustrated in Figure 6. The amplitudes are very small, which is as expected for the higher frequencies. Therefore, there is no need to continue to list the higher frequencies. None of these vibrations would occur for an undamaged 4-bladed rotor.

Figure 6. 5/Rev cockpit constituent vibrations G's vs. percent of blade removed.
